**FOURTH FIVE-YEAR REVIEW REPORT FOR
PORTLAND CEMENT SUPERFUND SITE
SALT LAKE COUNTY, UTAH**

**Utah Department of Environmental Quality
Division of Environmental Response and Remediation**

**U.S. Environmental Protection Agency
Region 8
Denver, Colorado**

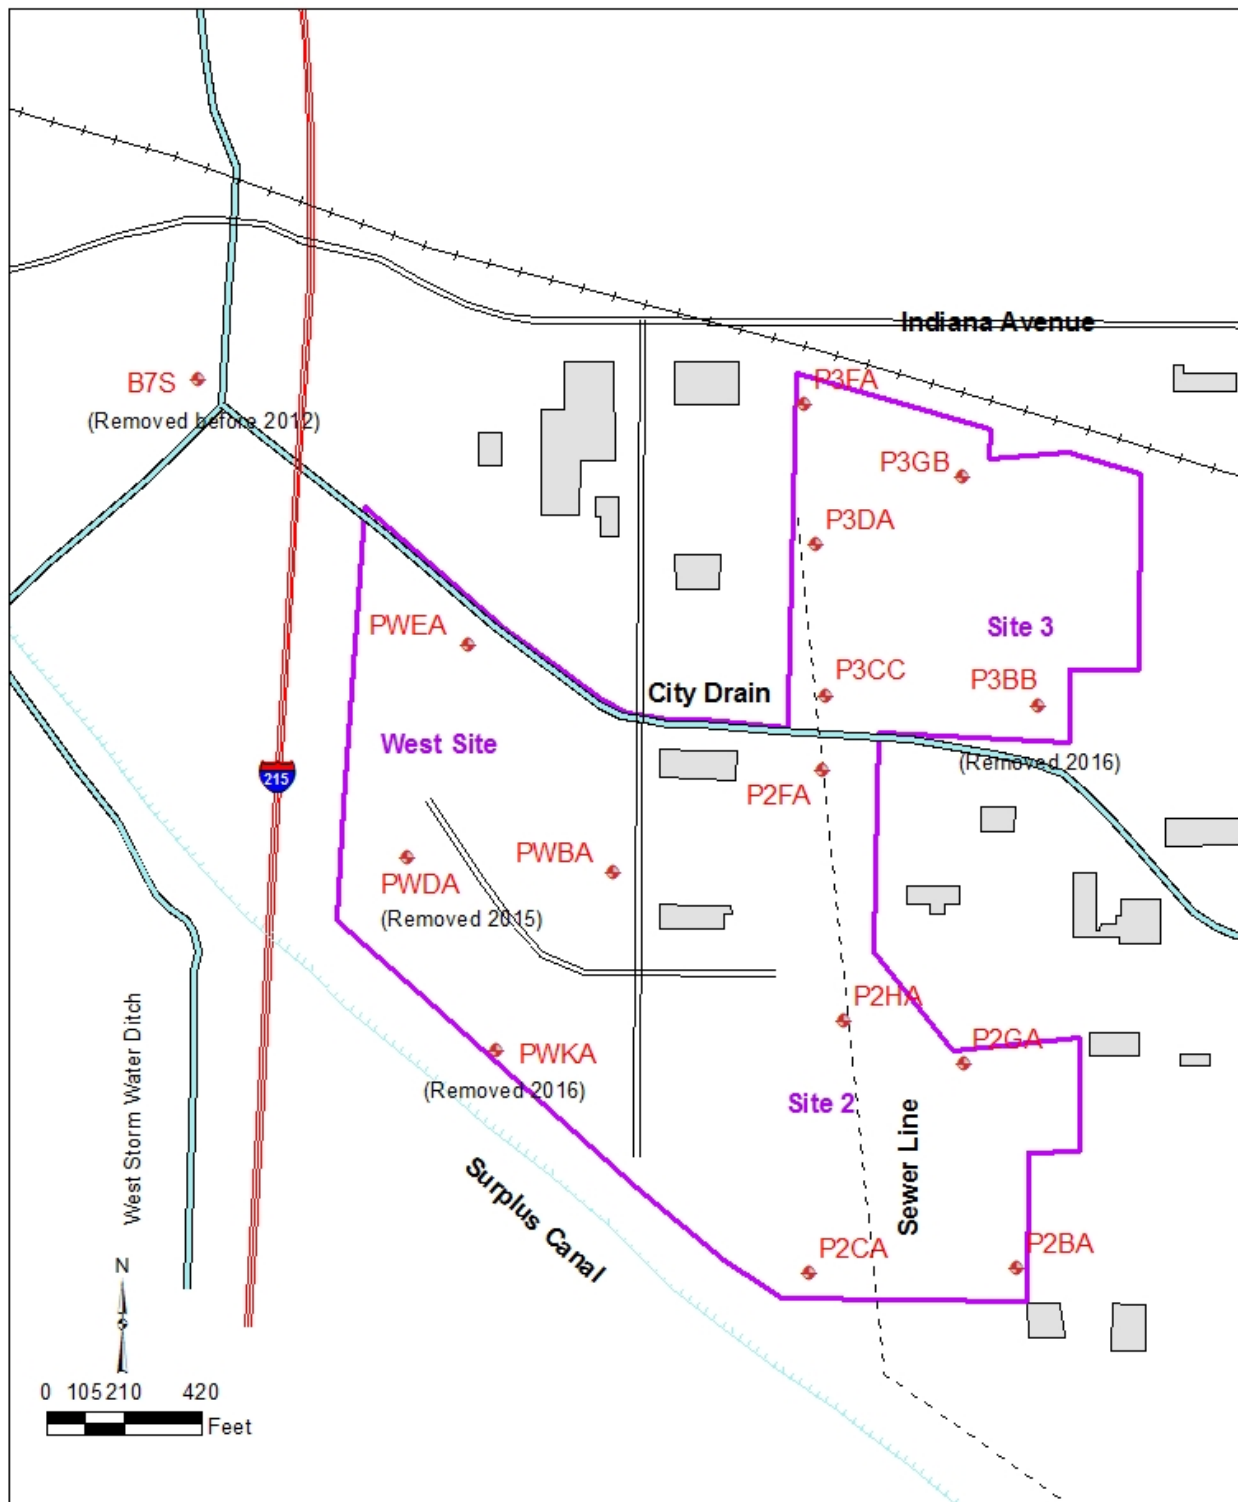
Figure 3
Shallow Aquifer Monitoring Well Locations
Five Year Review 2017
Portland Cement Site

Figure 3 shows the locations of the shallow aquifer monitoring wells currently being used as well as those that have been removed/damaged. Figure 4 shows the locations of the intermediate aquifer wells currently being used, as well as those that have been removed/damaged. All monitoring wells are monitored for arsenic, cadmium, chromium, lead, manganese, molybdenum, total dissolved solids and pH.

| Issues/Recommendations | | | | |
|---|---|---|---|---|
| | Recommendation: Coordinate repair/replacement of wells with property owners. Evaluate effectiveness of remaining wells to determine if monitoring well network is sufficient. | | | |
